# PRESCOTT PRESERVATION COMMISSION A G E N D A

**PRESCOTT PRESERVATION COMMISSION  
REGULAR MEETING/PUBLIC HEARING  
FRIDAY, December 14, 2012  
8:00 AM**

Staff Report  
December 14, 2012

**AGENDA ITEM: HP12-026, Request for approval for 4 ft high wrought iron fence in front and part of north side yard.**

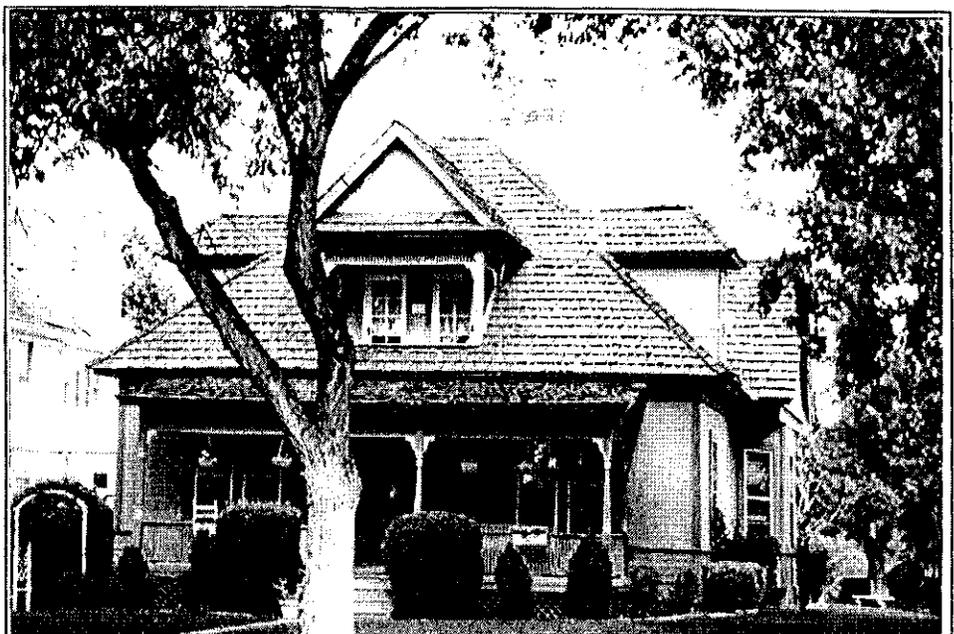
PHOTO INFORMATION

View of Direction (looking towards) East

Describe other character-defining features of its massing, size, and scale One and one-half story frame structure with symmetrical massing and an irregular plan. The main roof is a steep hip with gable extensions and dormers. This includes a skirted and shingled gable extension to the front that also incorporates a second level deck. A lower hip covers the front porch, which is supported by turned posts and jigsawed work.

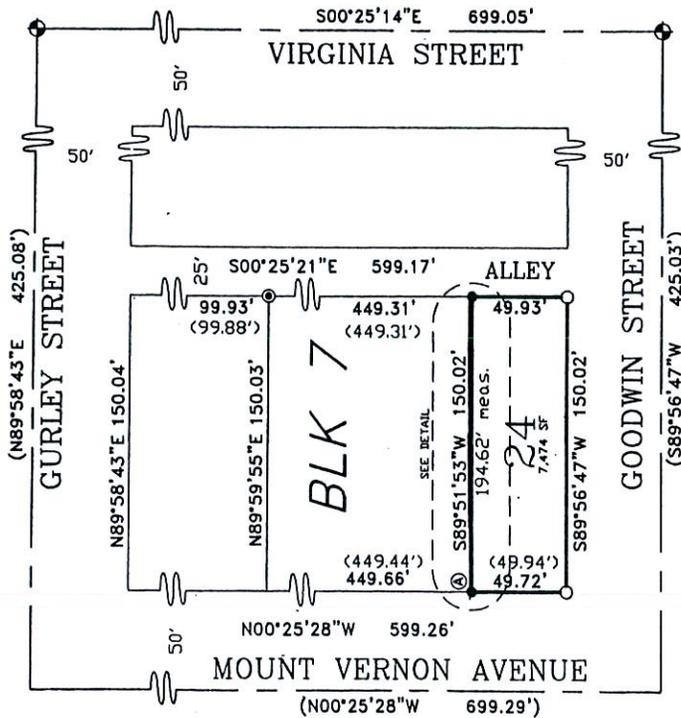
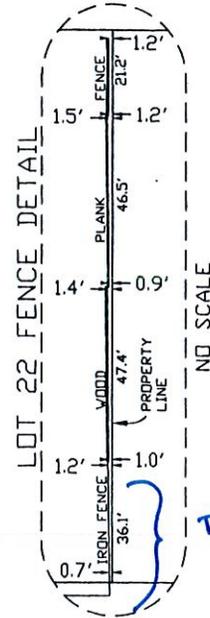
**CITY OF PRESCOTT  
COMMUNITY DEVELOPMENT DEPARTMENT  
BUILDING SAFETY DIVISION  
PLOT PLAN SKETCH**

Applicants propose to install a 4' high wrought iron fence along the front and extending 36' back along the north side property boundary. The wrought iron will transition to a 6' high wood plank fence that will extend back to the rear property line - see plan for fence location, and image for wrought iron fence style.

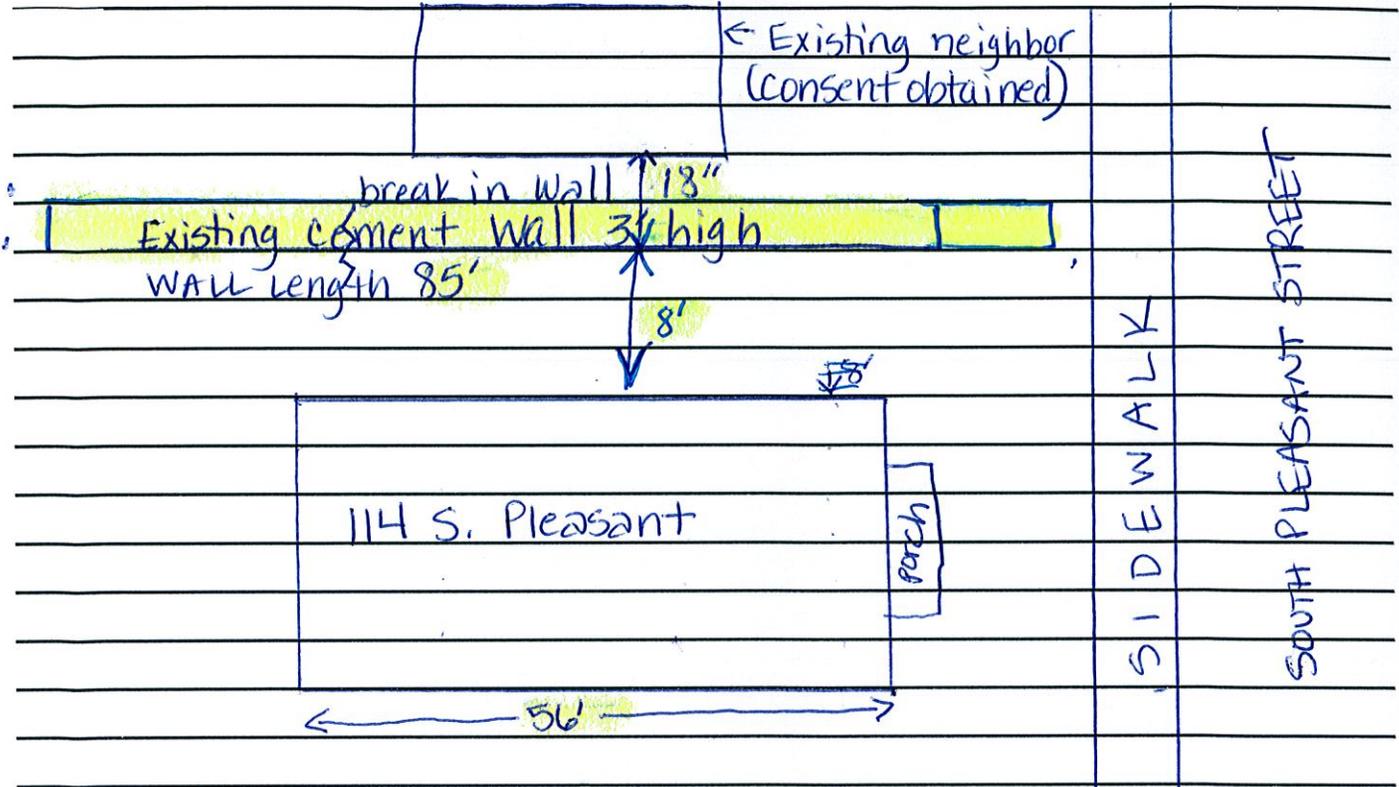
retainer wall location: 8" thick

see strips for wall locations

Failed concrete retainer wall to be replaced from location failure toward street with compac triplane block. 3' - 4' high.

See aerial photo of site

This property is within the boundaries of the East Prescott National Register Historic District and the Southeast Prescott HPD # 13. The home is listed in the National Register of Historic Places. The north edge of this property is above the grade of the property to the north, and relies on a retaining wall that varies in height up to about 4ft high. This wall is leaning strongly to the north and is undermined at the foundation level in certain sections.

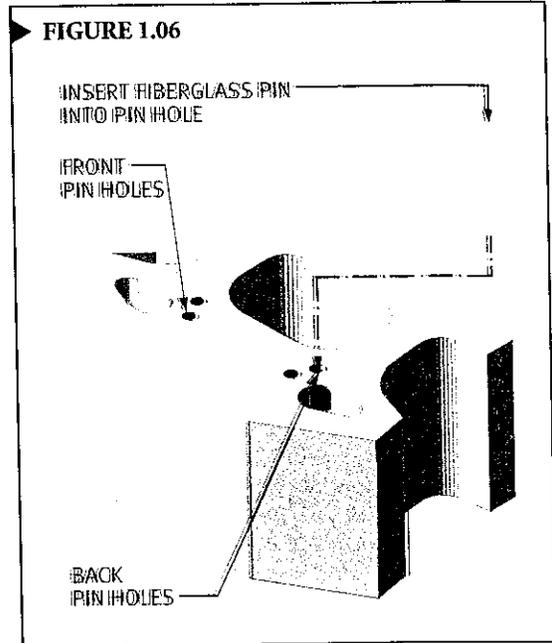
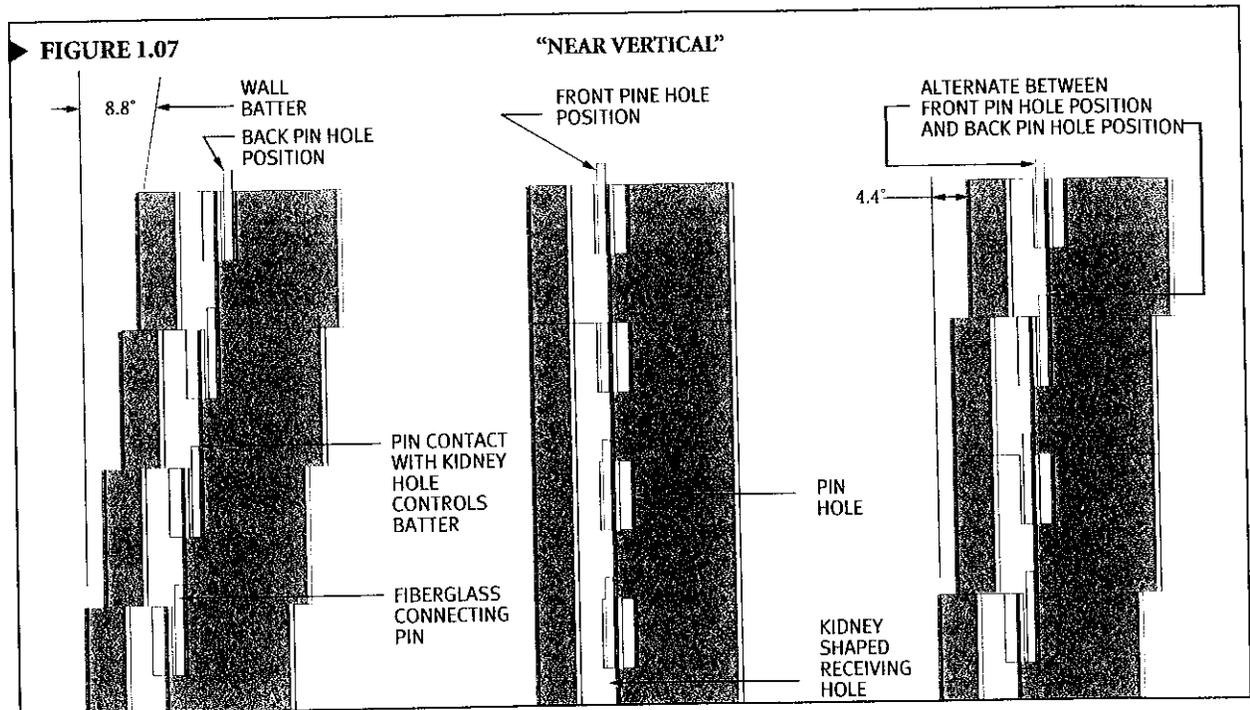
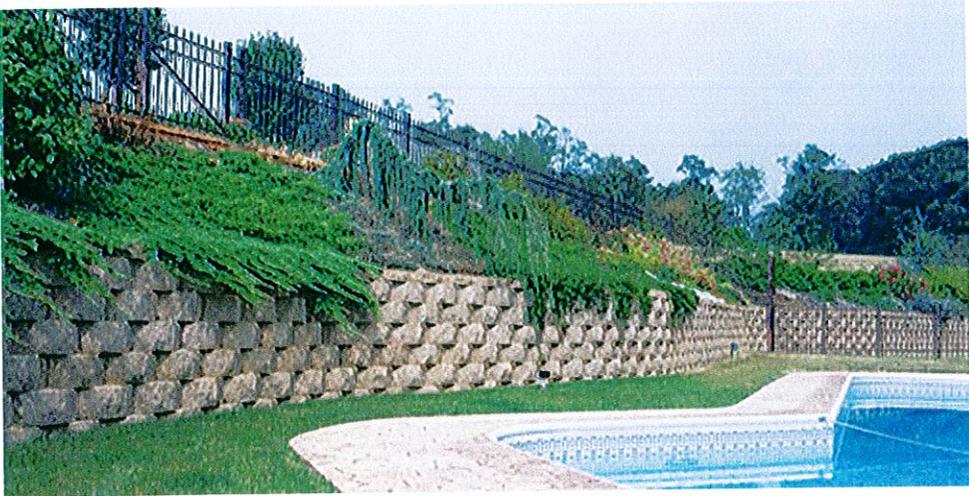
► STEP 5: INSERT FIBERGLASS CONNECTING PINS

Before installing the pins, select a batter option. "Batter" is the slope of the face of a wall upward and backward so that the wall leans into the embankment being retained. With Keystone®, batter is mechanically controlled by the pin position. Units with four pin holes appearing in the top of the Keystone® unit have three batter options; 8.8° (1-1/4" [30mm]), 4.4° (5/8" [15mm]) or near vertical. Units with only two pin holes appearing in the top of the Keystone® unit result in a 4.4° batter (1.07).

Place two Keystone® pins into two of the preformed holes in the top of each Keystone® unit (Figure 1.06 and IMAGE 04). In some cases a light slag film may cover part or all of the hole. In these conditions, use a hammer to tap the pin through the concrete slag and into the opening. Once in position, a minimum 1-1/4" (30mm) segment of the pin should protrude out of the opening above the top surface of the unit.

Figure 1.07 for slope installation example.
